# 593 BALL VALVES

**TESTING OF SUBMARINE SEA VALVES: (SS212-525) GLOBE, ANGLE, GATE,  
INCLUDING MANIFOLD**

SS(N)593 HULL SURVEILLANCE INSPECTION

SEA WATER PIPING, SS(N) 593  
FAILURE OF SILVER-BRAZED JOINTS

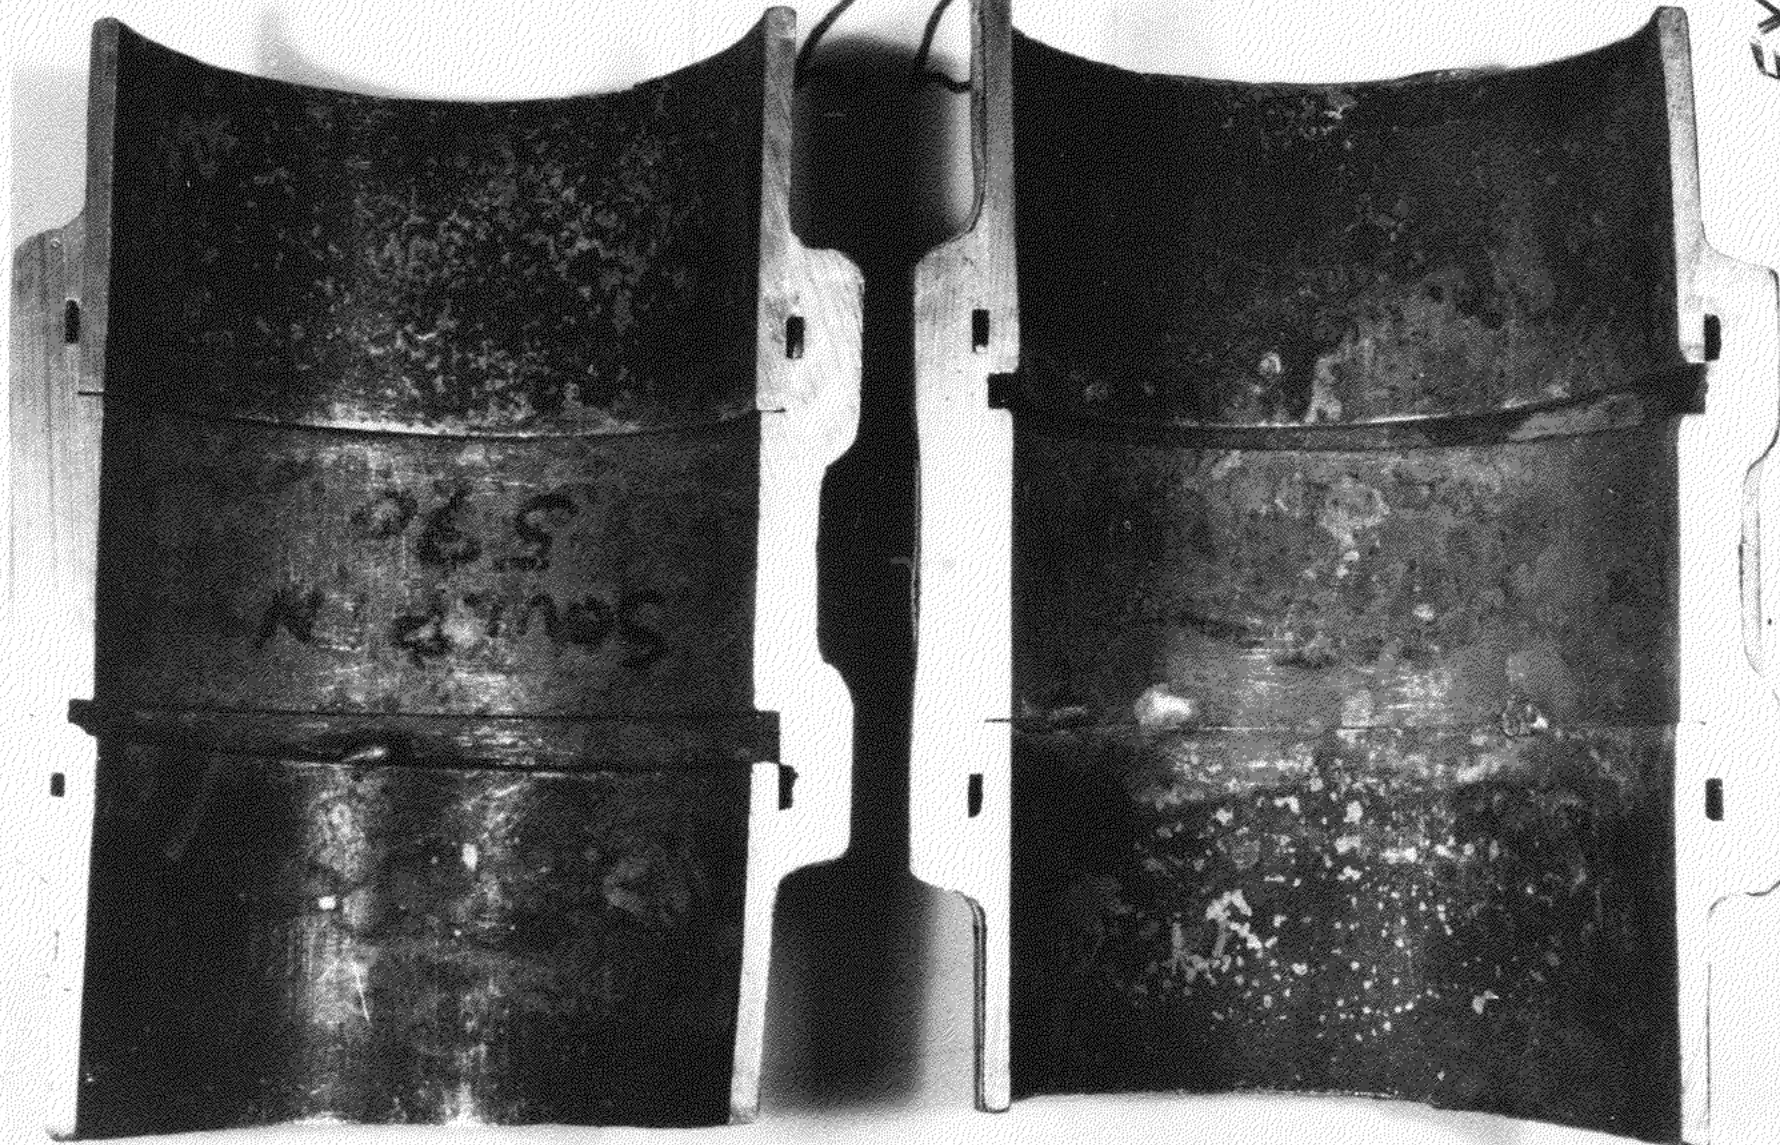
EXH 169

ULTRASONIC  
TEST  
Shows 10% Bond

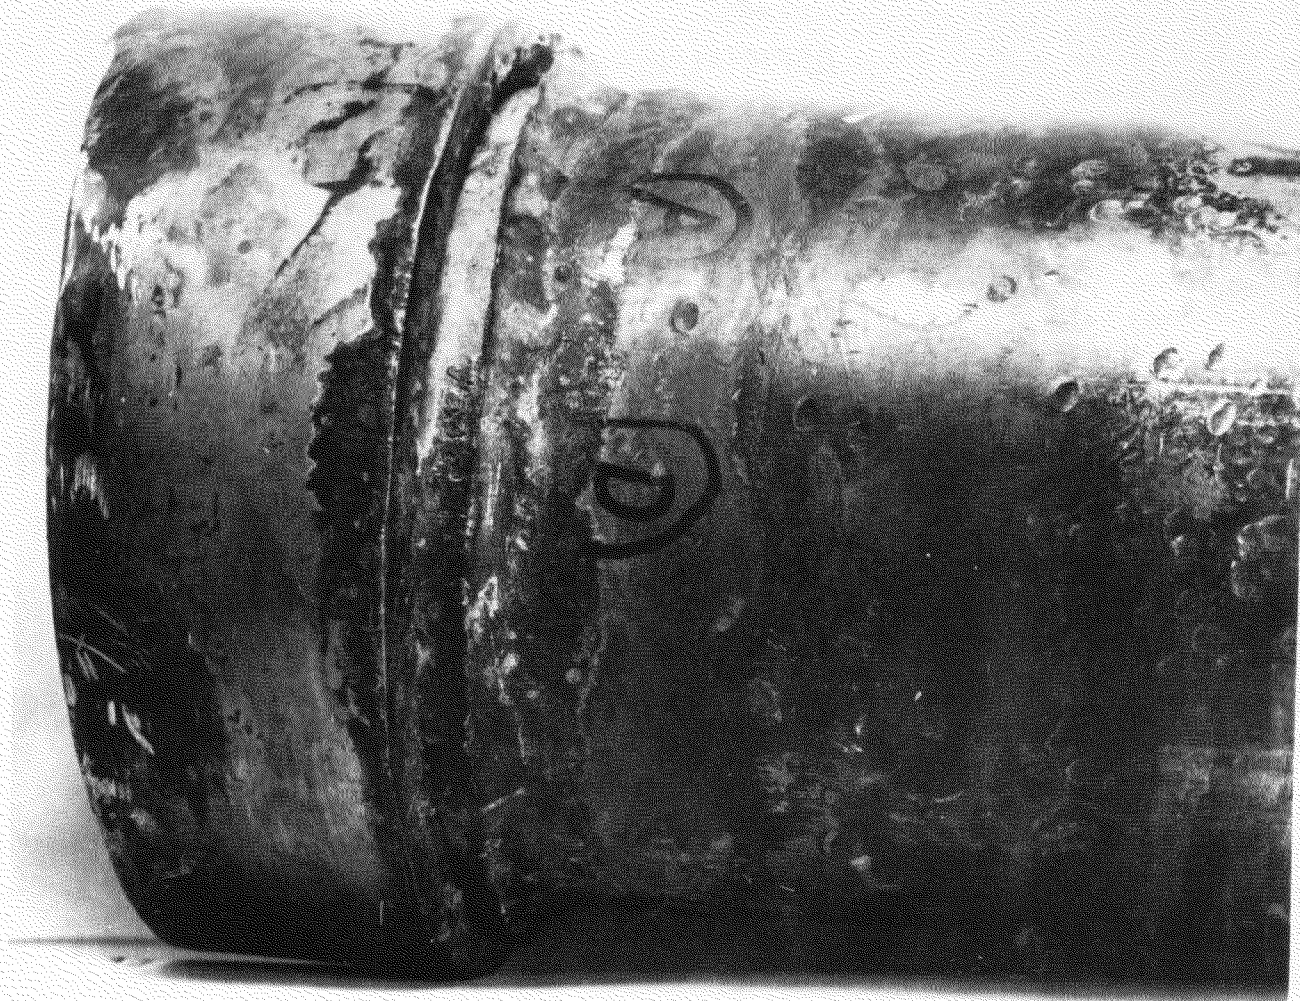
Exh 179-8 ENCLOSURE (1)

The 4" joint, although submarginal by latest standards, is considered to have been adequate for service intended. Failure was the result of pressure surge induced by rapid opening of TD-2 at test depth.

Photograph of 4" pipe showing a view of the area in which pipe separated from fitting.

On THRESHER, Valve TD-2 will be equipped with a pressure switch to prevent opening at depth below 100 feet. The hydraulic circuit to operate on TD6 will be equipped with a flow control check valve to permit slow opening time (approximately 7 secs.), and rapid closing time (1-2 secs.).

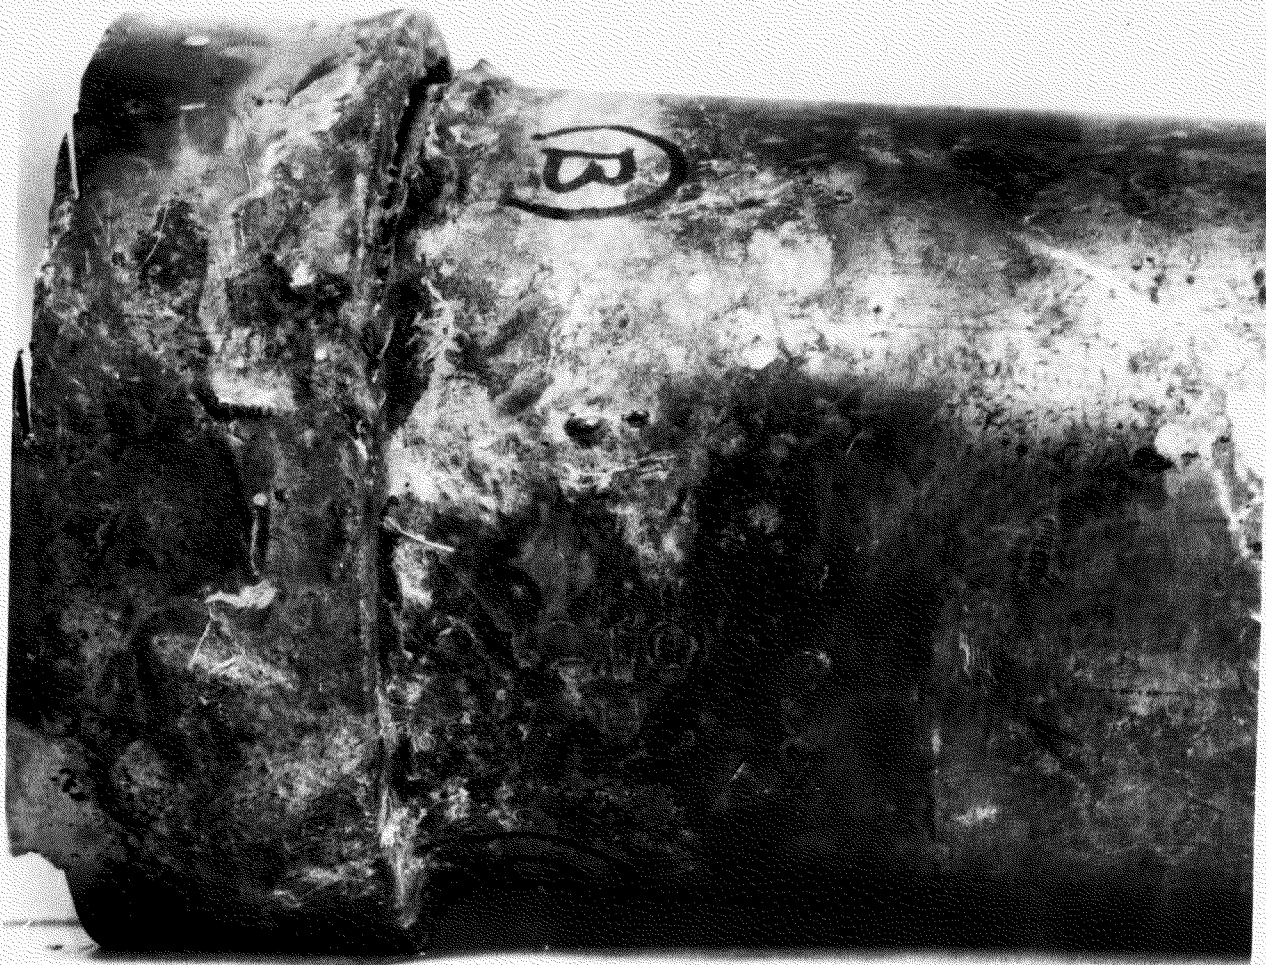
Exh 179-9 ENCLOSURE (2)

Photograph of 4" pipe showing a view of the area of pipe that held.

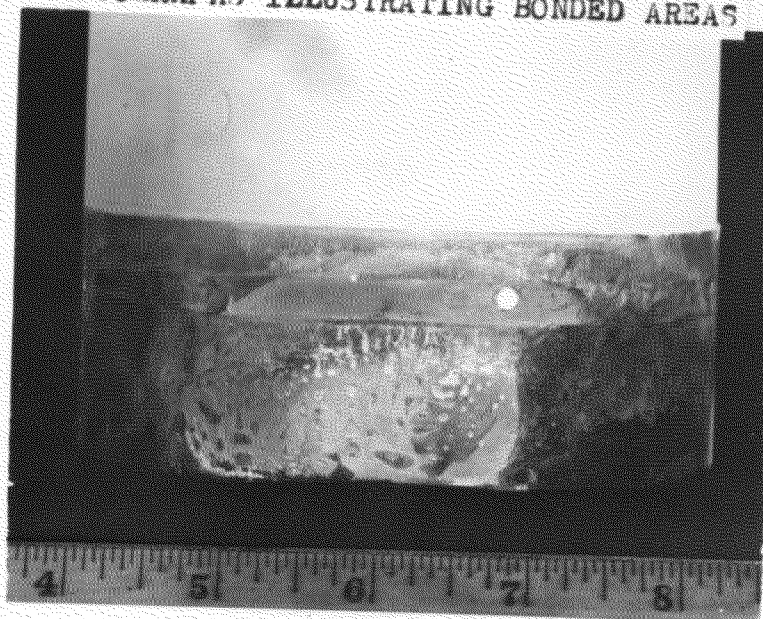
Fig. 1-Section of pipe joint which held during initial failure at sea.

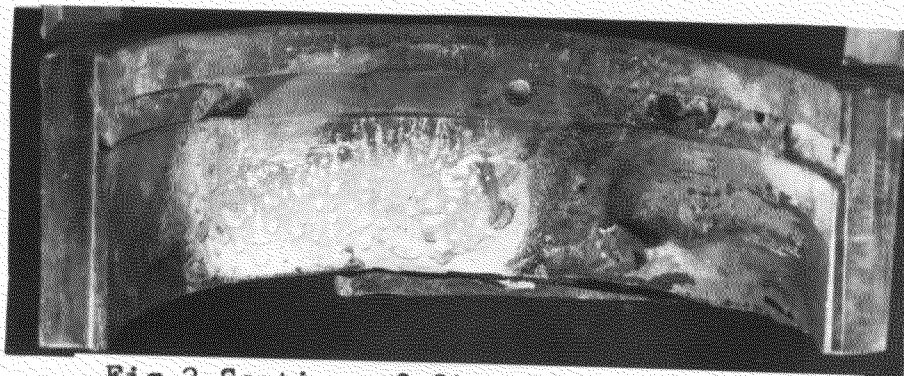
Fig. 2-Section of fitting conforming to area shown in Fig. 1.

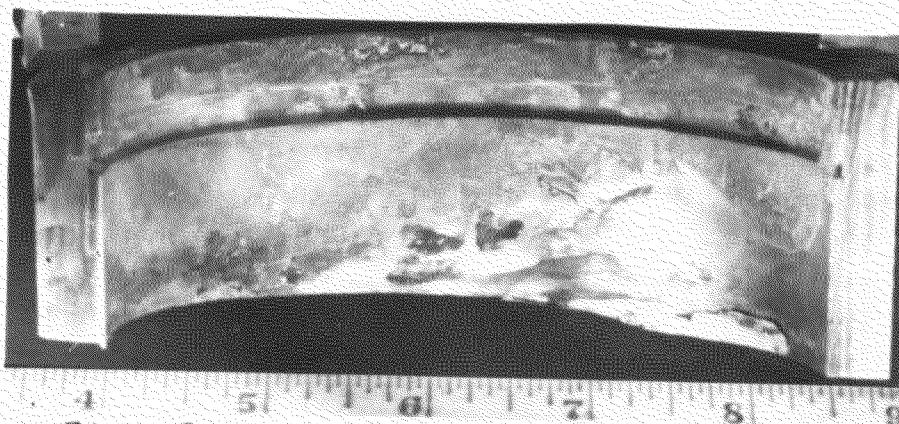
Fig. 3-Section of fitting illustrating that part of the joint that ruptured at sea.

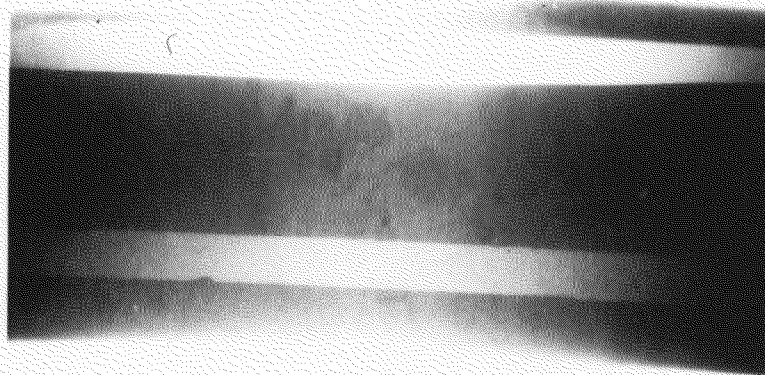
Fig.1-Photographic print of radiograph taken in area that failed in service, illustrating complete melting and flow of the insert ring. Silver alloy can also be detected by the mottled appearance.

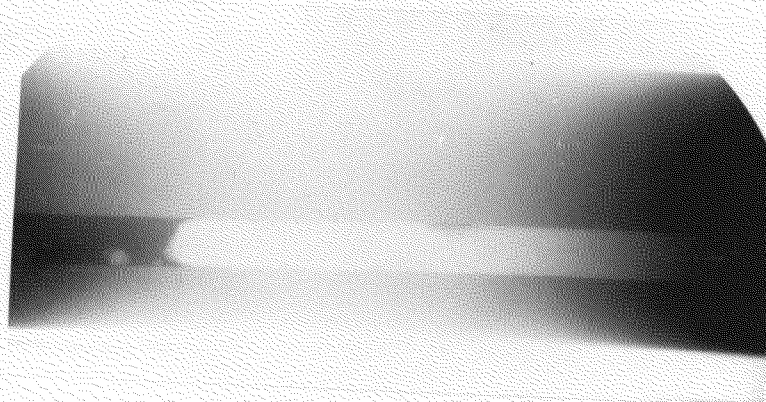
Fig.2-Photographic print of radiograph taken in area that held. The presence of solder in groove is noted.

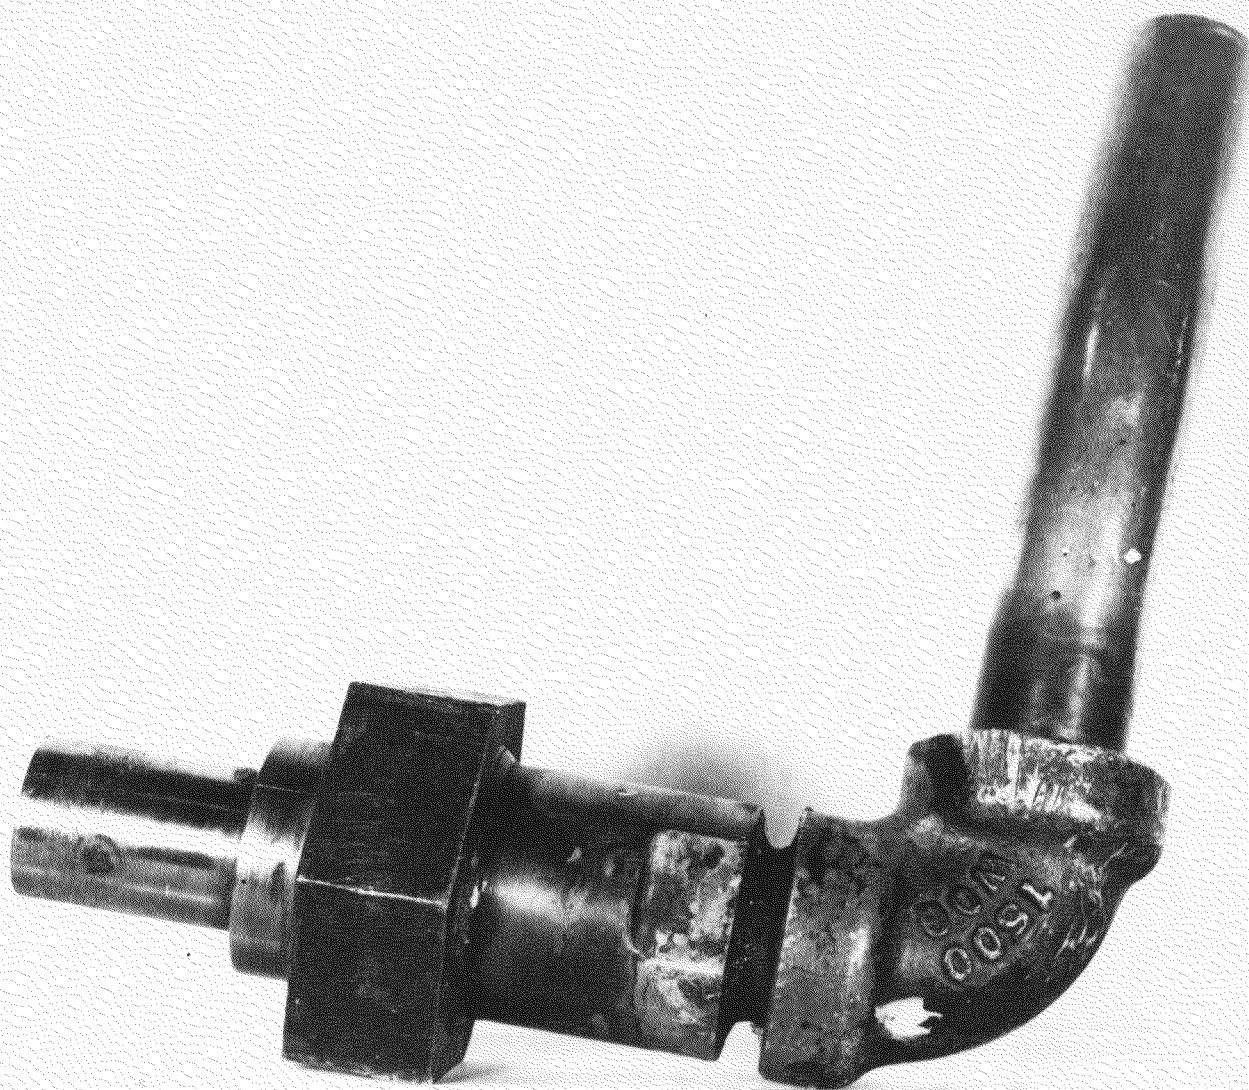
Exh 159-12

Photograph of 3/4" IPS Nickel-Copper Union that ruptured at sea.
